GC COLUMN

Installation Quick Guide

GC Troubleshooting

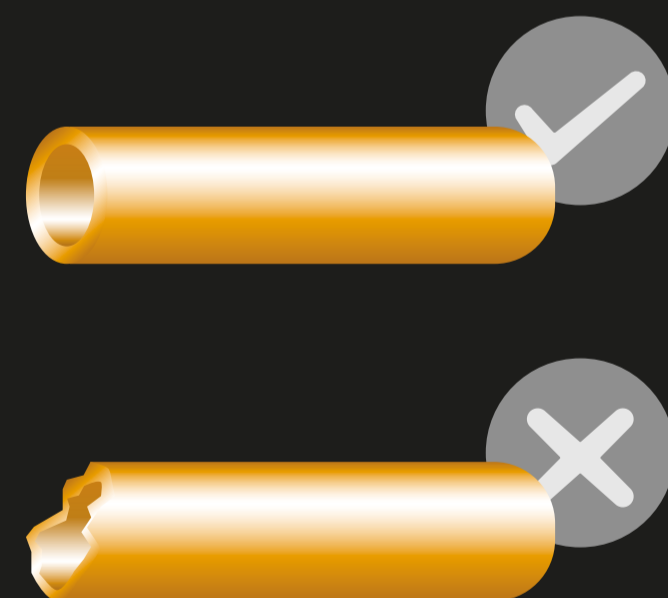
Proper & Improperly Cut Capillary

4. Cut 1 – 2 cm using a ceramic scoring wafer from each end of the column, use a magnifying glass to ensure column is smooth/straight.
5. Install column at the appropriate length to the injector and detector, using the handy SCION column ruler tool.

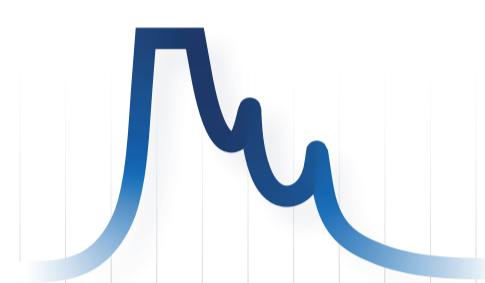
LONG SOLVENT PEAK TAIL

Possible cause	Solution
Injector temperature too high	Lower initial injector temperature.
Injector leak	Check septa, liner, and column installation and injector fittings.

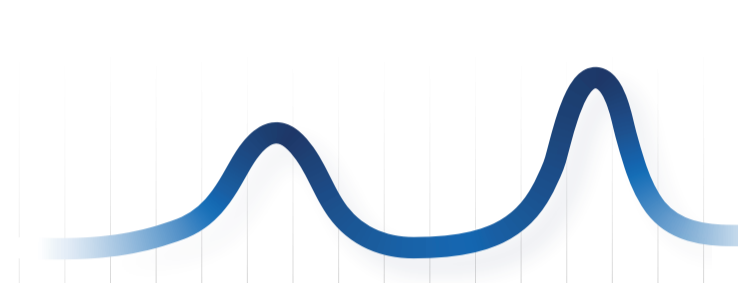
NO SAMPLE PEAK / LOW RESPONSE

Possible cause	Solution
Injector leak	Check septa, liner, column installation and injector fittings.
Syringe leak	Replace the syringe.
Broken column	Replace column.

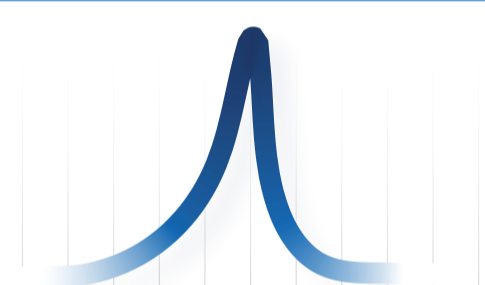
PEAK FRONTING

Possible cause	Solution
Overloaded column	Decrease injection volume, dilute sample or use columns with thicker film.
Restriction of the carrier gas flow	Check injection liner and column connections for any obstructions.

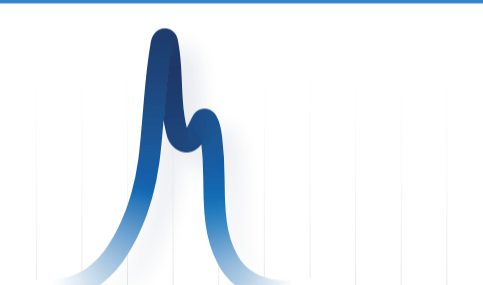
SPLIT PEAKS

(Multiple peaks corresponding to a single compound)

Possible cause	Solution
Injection volume is too large	Change method injection volume.
Injector temperature is too low	The temperature should be no more than 20°C below the boiling point of the sample diluent.
Improper column installation	Reinstall column.

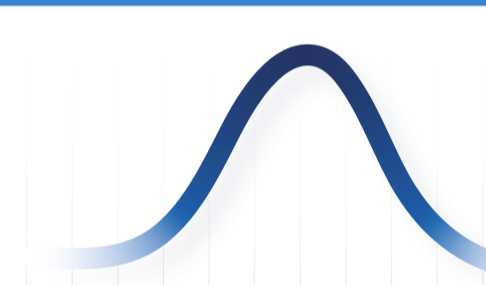
PEAK BROADENING / POOR RESOLUTION

Possible cause	Solution
Degraded column	Recondition column. If no improvement is seen, ultimately replace the column.
Contaminated liner	Replace liner.
Wrong carrier gas flow	Check carrier gas flow.

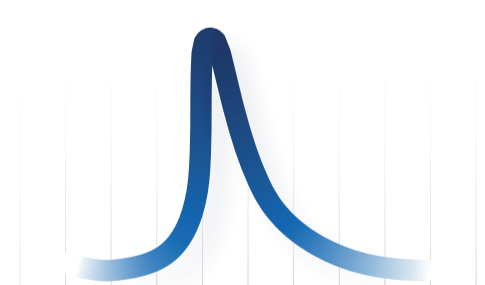
PEAK TAILING

Possible cause	Solution
Column degradation	Cut length of column from inlet end and reinstall – if no improvement consider replacing column.
Sample adsorption	Recondition column.
Contaminated or blocked liner	Replace liner.
Increased dead volume	Check make-up gas flow, injector assembly and column connections.
Improper functionality of the injector heating	Check injector heating/cooling functions.

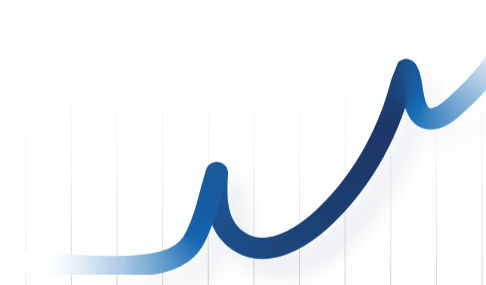
EXTREME BASELINE INCREASE DURING TEMPERATURE PROGRAMMING

Possible cause	Solution
Column temperature limit is exceeded	Reduce maximum temperature. Change the column film thickness with regards to the sample. For high non-polar compounds with a high retention time, a film thickness of 0.1 is advised.
Contamination	Check gas filters. Correct all leaks, condition the column.
Instrument problems	Use an uncoated column and rerun the temperature program. If no problems arise from this run, the column being an issue can be excluded.
